FACT SHEET

Demons Bluff Beach Closure

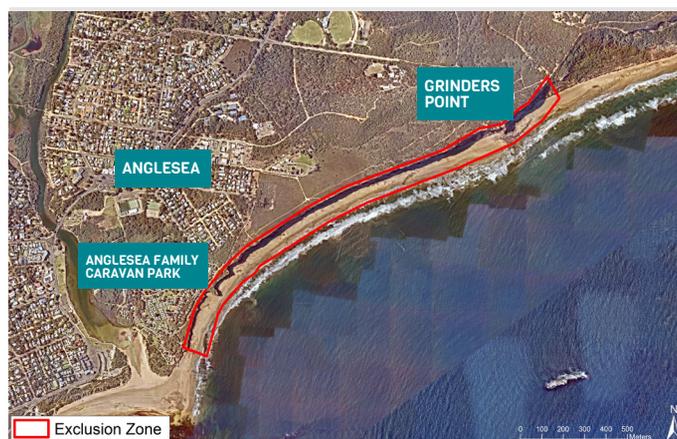
- An exclusion zone has been set from 100-metres north of the Anglesea Family Caravan Park beach access ramp to 300-metres past Grinders Point. The extent of the exclusion zone can be seen below in Figure 1.
- Permanent signage will be installed onsite to inform users of the exclusion zone.
- Only authorised individuals are permitted to enter the exclusion zone, access for all other individuals is prohibited.

Figure 1 - Exclusion zone.

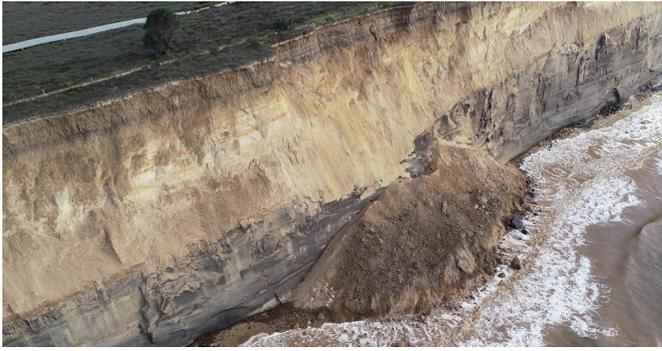
Collapses, also known as cliff failures, occur when the internal strength of the formation is reduced beyond a threshold where it can no longer support its weight. Due to the softness of the rock, the Demons Bluff cliffs are easily eroded, and they continually experience both large and small landslips and collapses (see *Figure 2*). These landslips are unpredictable and can occur without warning, posing a significant risk to clifftop and beach users.

Figure 2 - Demons Bluff cliff failure, 2019.

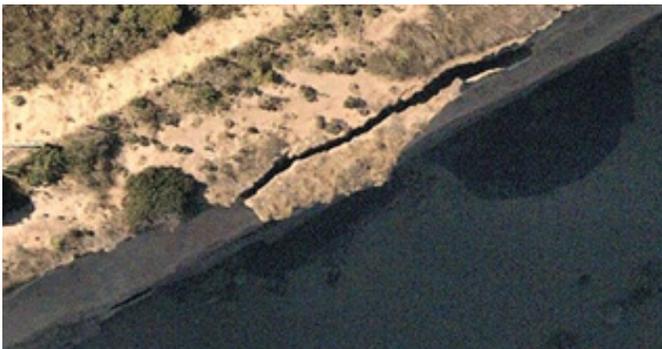
Following the identification of a 60-metre tension crack in the clifftop, DELWP, Parks Victoria, and the Authority formed a collaborative working group to understand the risks associated with this section of the cliff. The working group has taken the following actions:

- An independent geotechnical risk assessment was commissioned, which showed that the risk to life was unacceptable as defined by the 'Australian Geomechanics Society Landslide Risk Management Concepts and Guidelines 2007'.
- Following the risk assessment, a decision was made to temporarily close the beach until a long-term risk management approach could be adopted to reduce the risk to a tolerable level.

Figure 3 - Demons Bluff tension crack, 10 February 2021.

Unfortunately, a permanent beach closure is considered by the Authority, DELWP and Parks Victoria as the only appropriate course of action to take at this location. Although the group recognises that this will affect the public's current use of the beach, closure was assessed as the only viable option to ensure public safety.

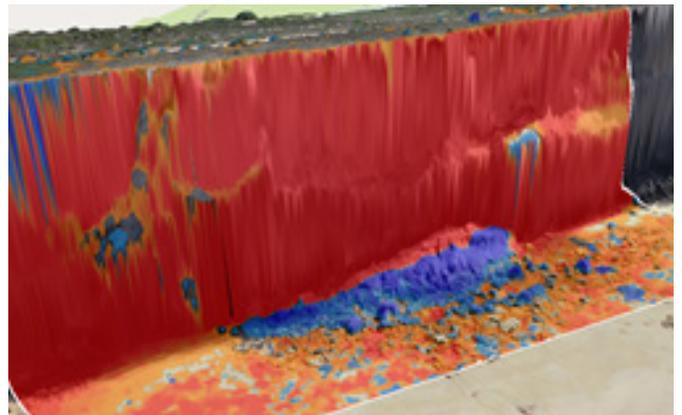
Figure 4 - Drone survey data showing uniform erosion (red).

- Installation and maintenance of fencing and signage on the clifftop to keep users away from the cliff edge.
- Continued relocation of the Surf Coast Walk inland away from the cliff edge as erosion encroaches landward.
- Regular geotechnical investigations.
- Ongoing monitoring including site visits, aerial imagery analysis and drone surveys (see *Figure 4*).
